VIZCAYA, ROSE GARDEN  
(Vizcaya, Fountain Garden)  
3251 South Miami Avenue  
Miami  
Miami-Dade County  
Florida

HALS FL-27-B  
*HALS FL-27-B*

## HISTORIC AMERICAN LANDSCAPES SURVEY

### VIZCAYA, ROSE GARDEN (Vizcaya, Fountain Garden)

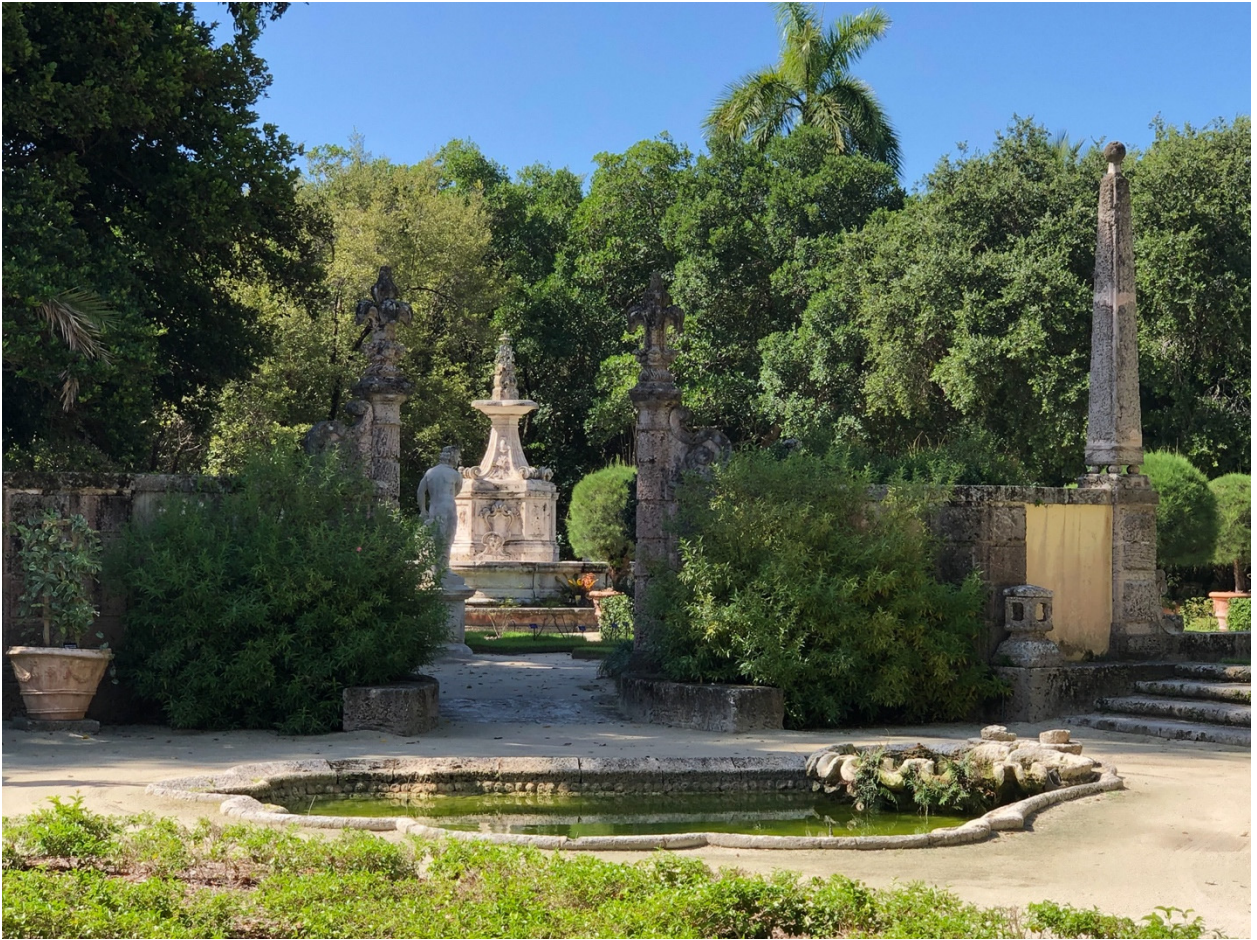
View looking East toward Rose Garden Fountain with Mangrove hammock beyond. (Image Credit: Rocco Ceo, 07.14.2022)

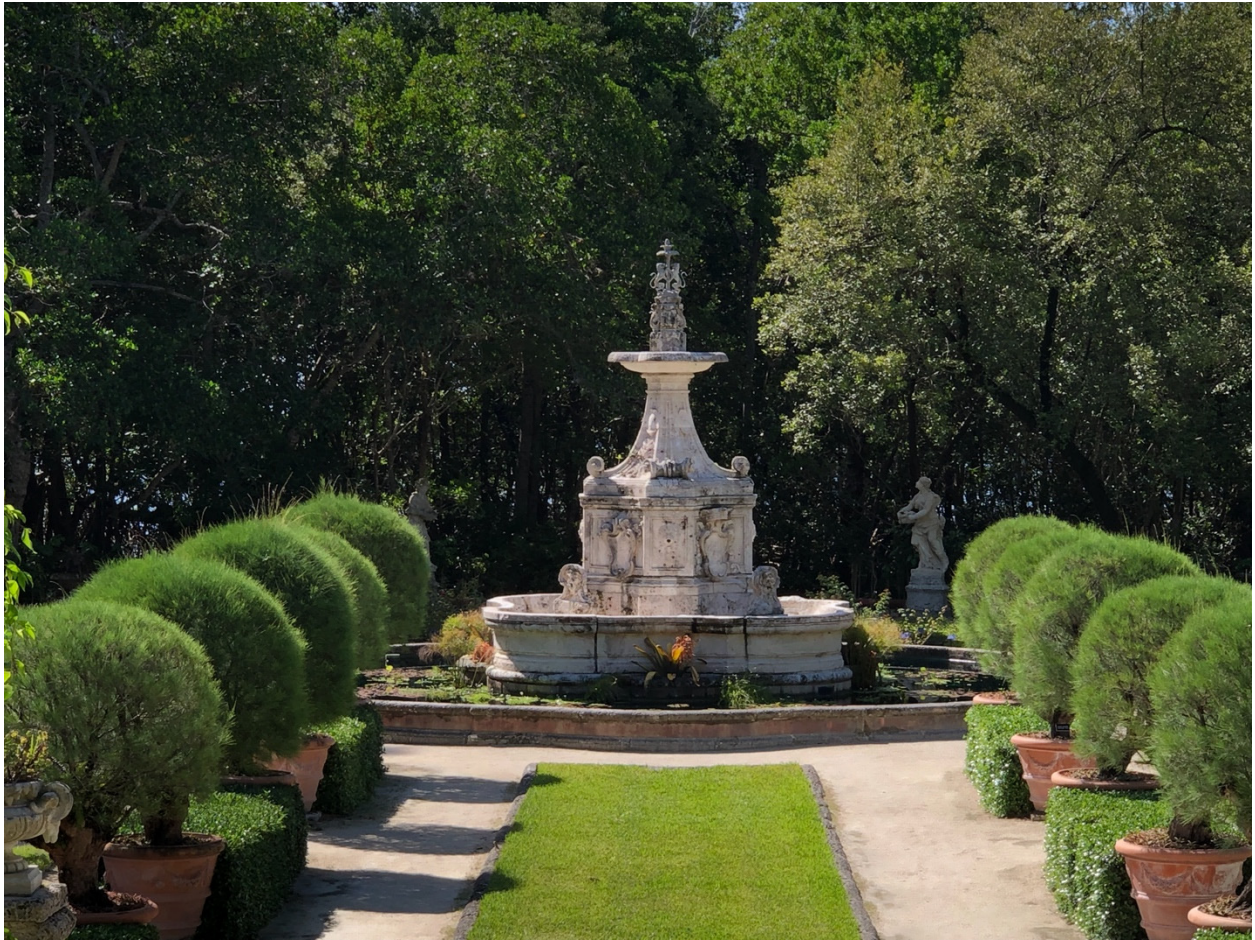
View of the Rose Garden, Fountain and potted topiary against the Mangrove hammock beyond from the Casino Mound. (Image Credit: Rocco Ceo, 07.14.2022)

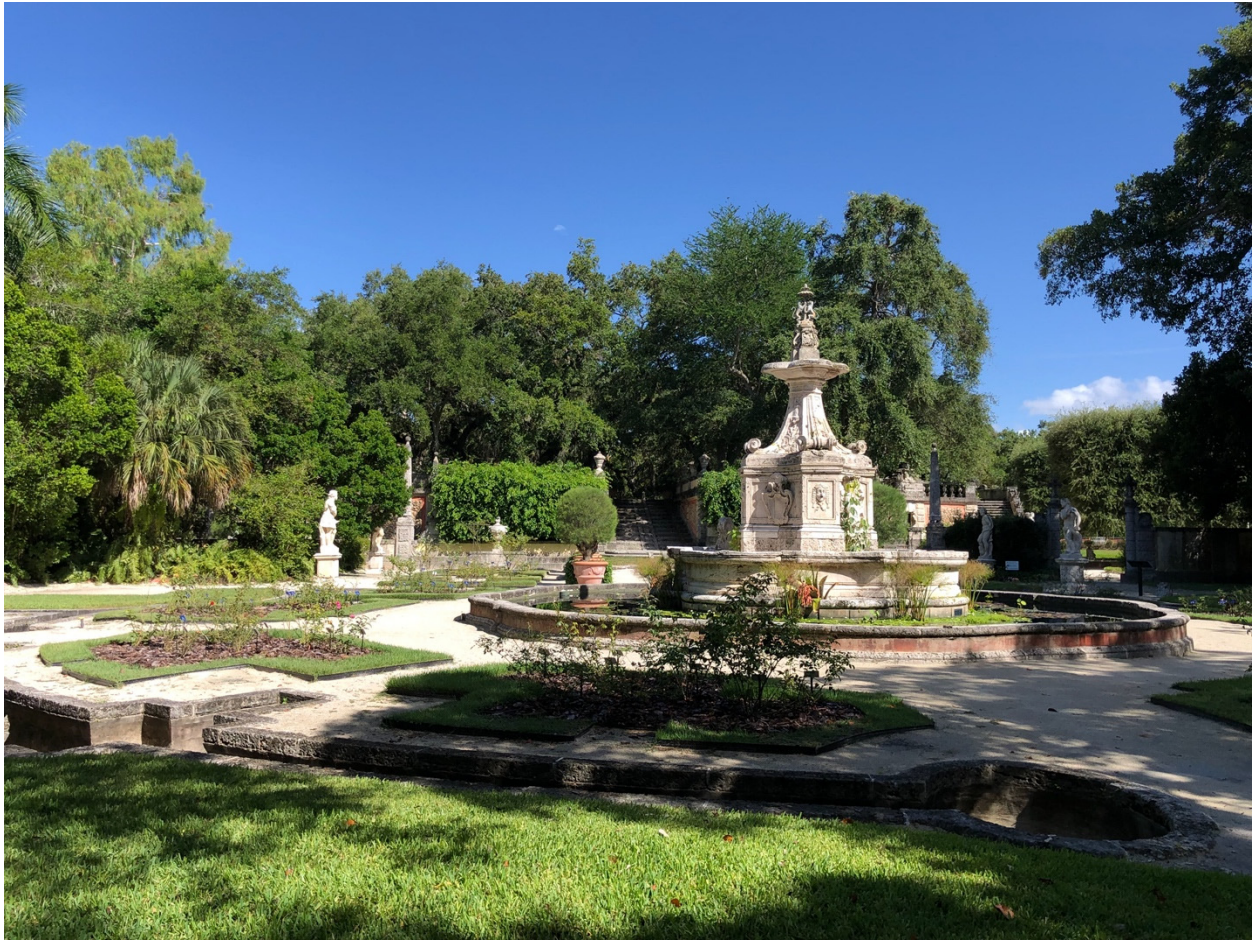
View looking West across Rose Garden, Fountain, Canal and Statuary toward the Casino Mound. (Image Credit: Rocco Ceo, 07.14.2022)

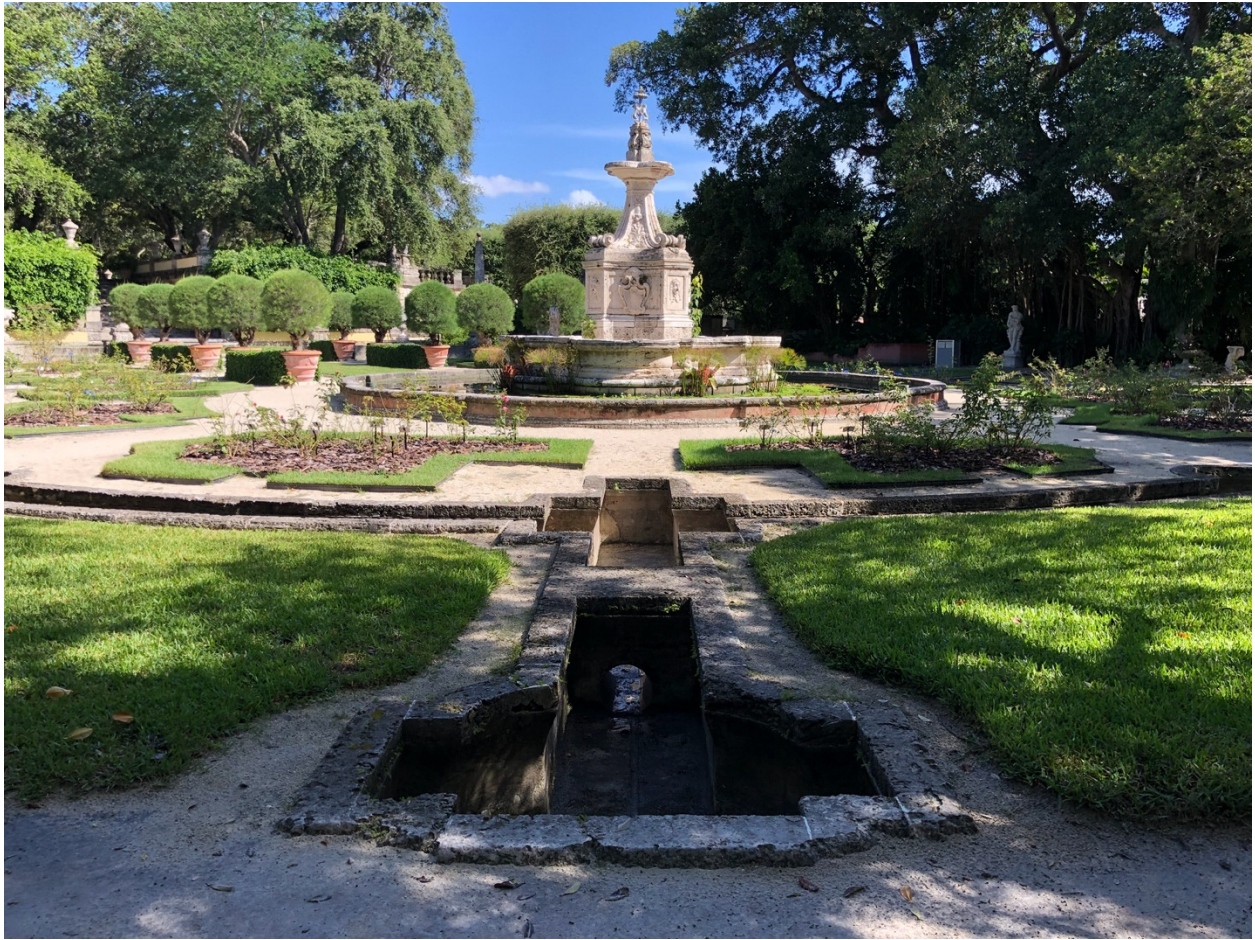
View looking North across Southern Canal (W3) toward fountain and Formal Garden beyond.  
(Image Credit: Rocco Ceo, 07.14.2022)

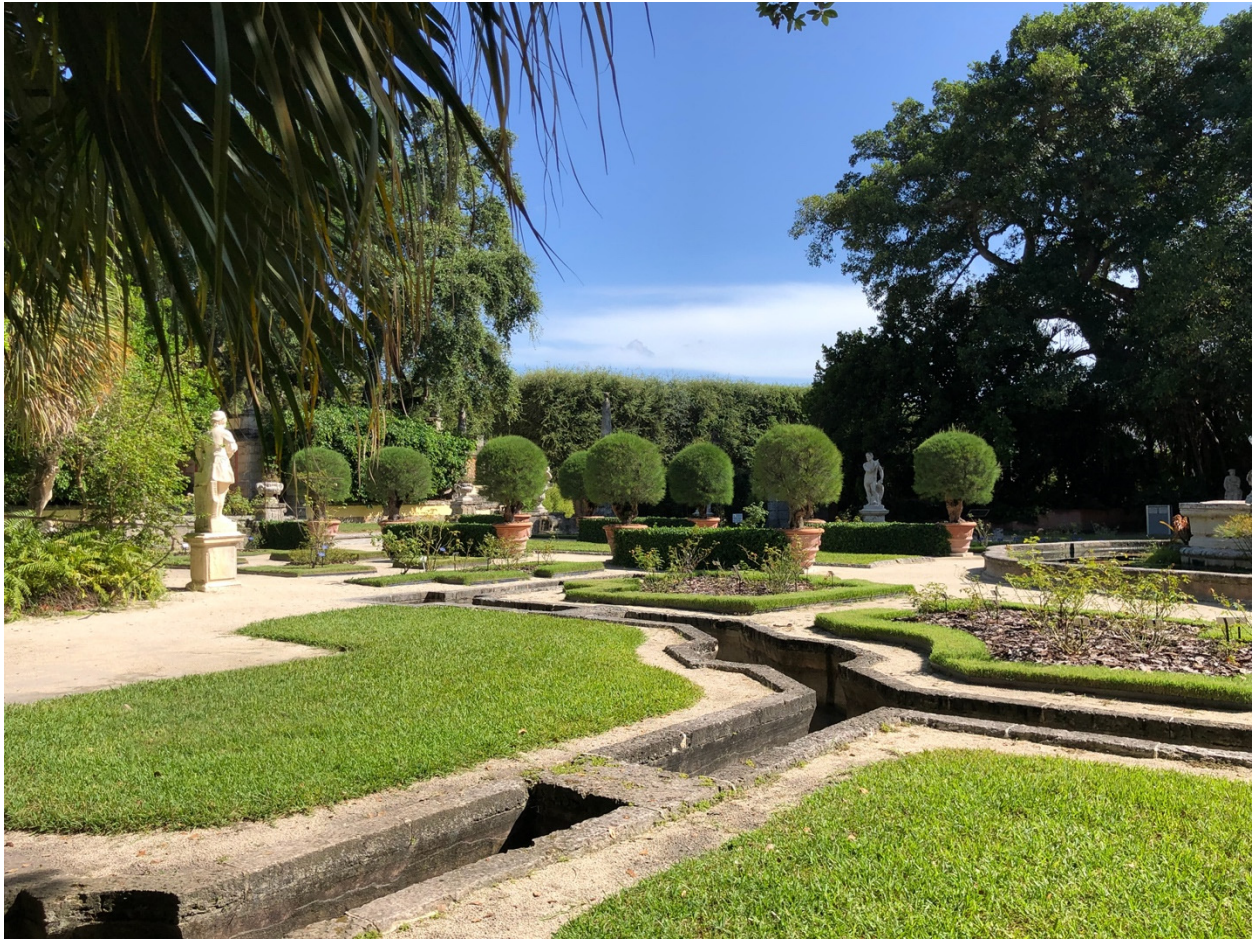
View looking across (W5) Canal and potted Australian Pine topiary toward Formal Garden.  
(Image Credit: Rocco Ceo, 07.14.2022)

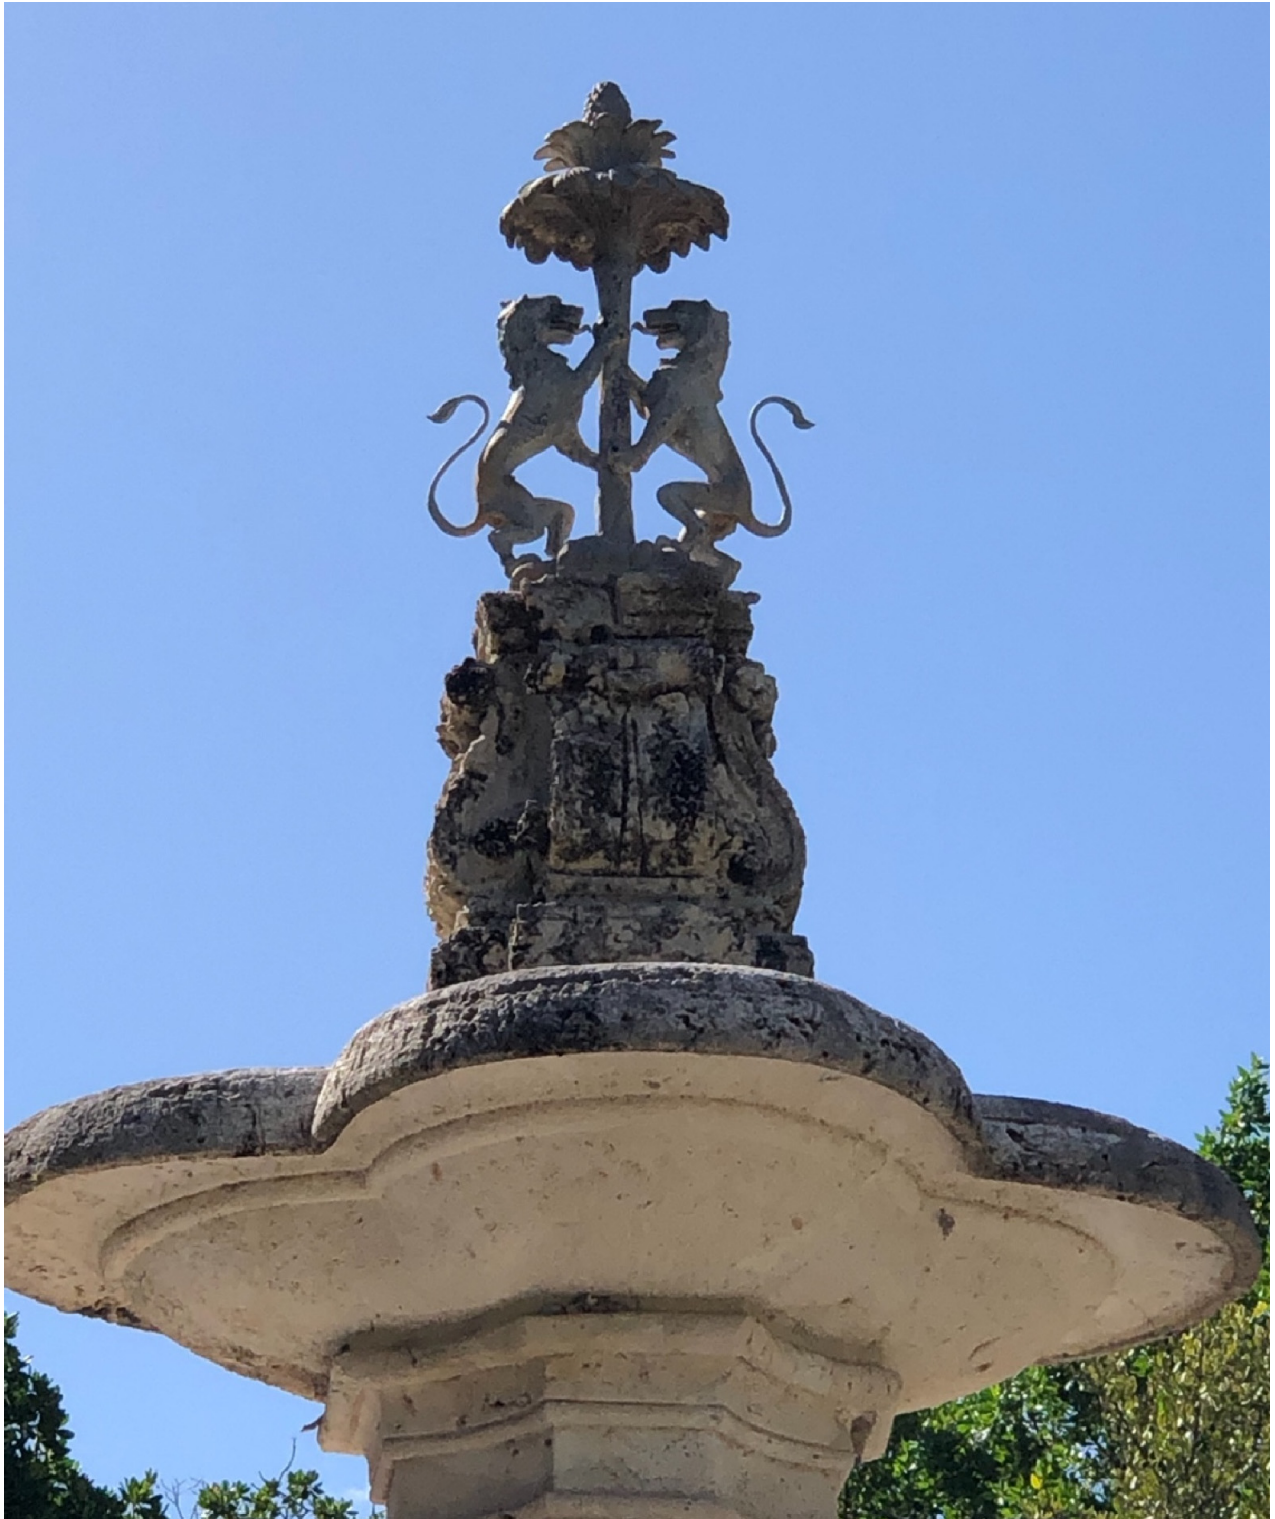
View of the top of the Rose Garden Fountain showing finial. (Image Credit: Rocco Ceo, 07.14.2022)

*01 June* – Photograph showing almost finished view of fountain only finial at the top is missing. (VA Historic photograph Vol. XI, pg. 26, 8x10 photograph.)
